MWPS-75265

16 x 20 Milkhouse

MIDWEST PLAN SERVICE
Cooperative Extension Work in Agriculture and Home Economics and Agricultural Experiment Stations of North Central Region - USDA Cooperating
16 x 20 Milkhouse
Title Page
MIDWEST PLAN NO. 75265

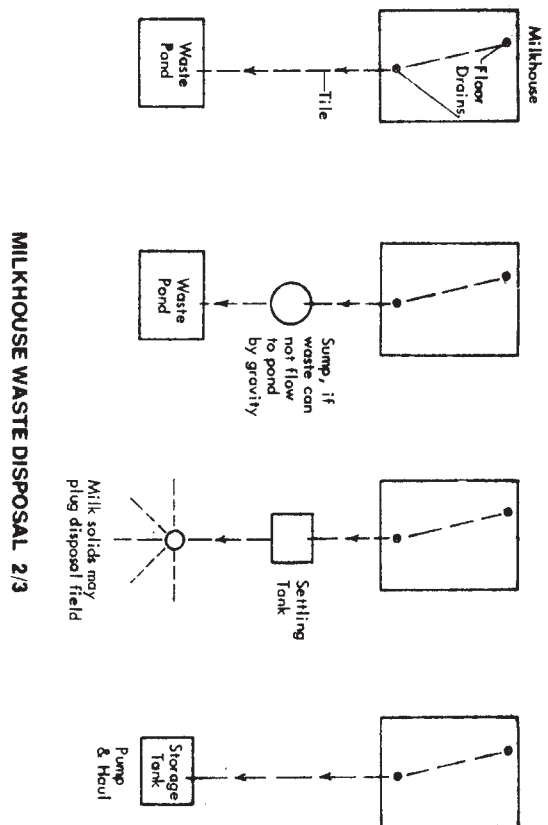
MILKHOUSE WASTE DISPOSAL 2/3

If liquid manure handling is used in the dairy barn, milkhouse wastes may go into the manure tank.
